RAINSHIELD ENGINEERS INC.
PROJECT NO: R23-032

2024 Depreciation Report

At 550 Royal Avenue, New Westminister, BC

Strata Corporation Plan NW 1592- Harbourview

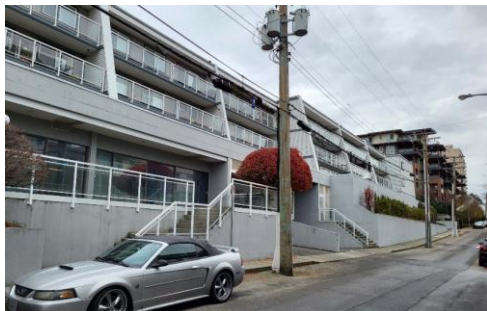
At the time of the visit, no evidence of building structure distress was observed.

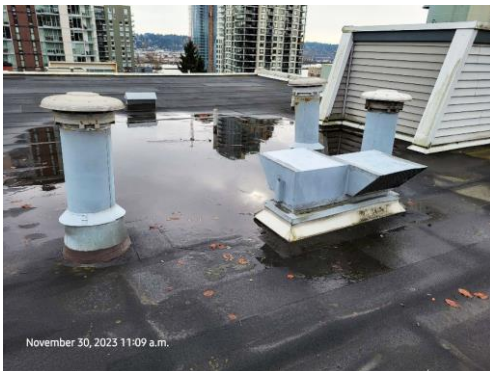
The waterproofing membrane had aged and reached beyond the service life. Replacement is required.

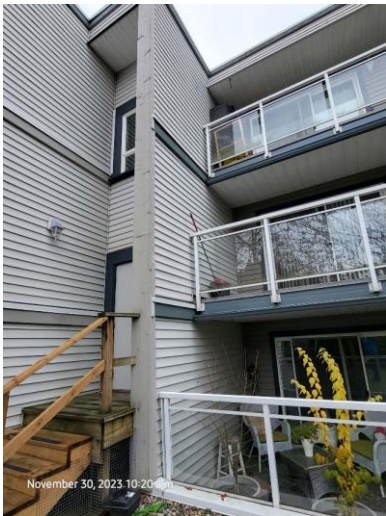
The Strata advised that the new rainscreen cladding was installed around 2005.
 The exterior walls are in reasonable condition for their age.

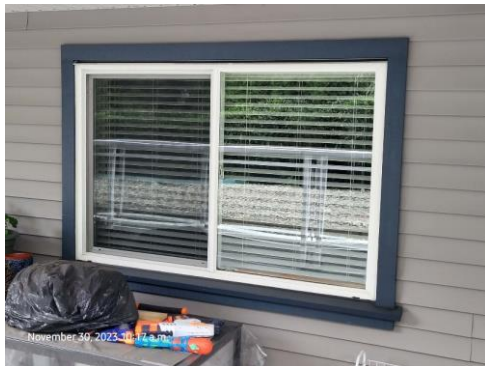
The Strata advised that the window installation was done around 2005 during the building envelope repair work.

No water ingress through the windows was reported and observed at the time of this report preparation.

The windows are in reasonable condition for their age.

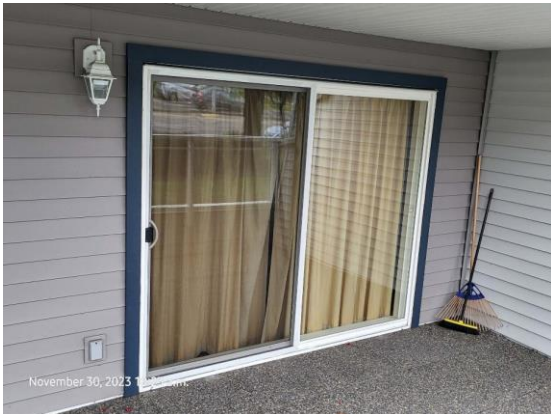
The balcony and patio vinyl sliding doors were replaced around 2005 in conjunction with the building envelope repair work.

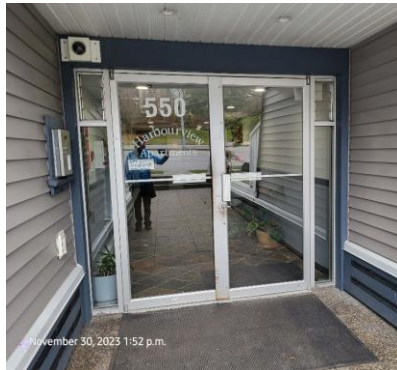
Commercial storefront glazing

The storefront glazing product is not designed watertight. The storefront glazing is partially protected under the overhang. Adequate waterproofing detailing at the rough openings is critical to safely drain rainwater away from the building interior.

It was reported that approximately 30% of the existing insulated glass units have failed and condensation has occurred in the insulated glass units.

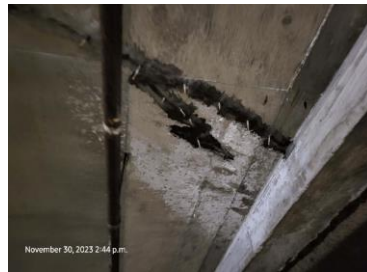
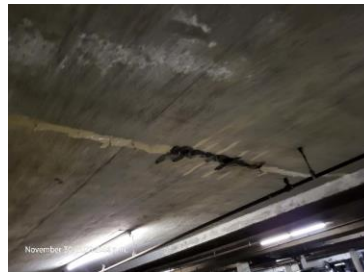
P2 parking garage roof slabs (under the commercial unit west and south walkways and planters)

It is probable that the waterproofing membranes on the west and SW walkways were replaced during the building envelope repair work in 2005.

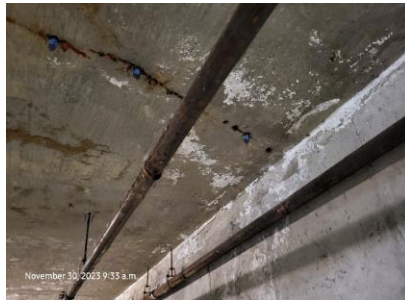
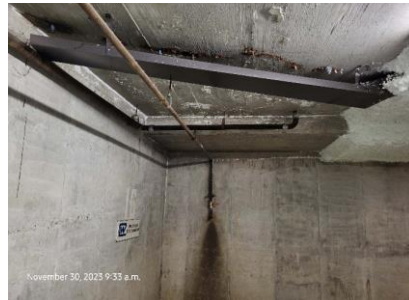
Considerable water ingress was noted on the walkway beside the loading area.
