## Project Completion Report

2024 Roof Repairs & Maintenance  
WO# 17958

**Building Name:** Harbourview NWS1592

**Building Address:** 550 Royal Avenue New Westminster

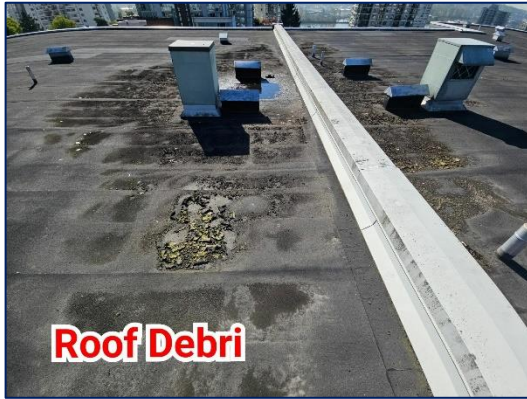
Before: Debris and loose moss at roof surfaces.

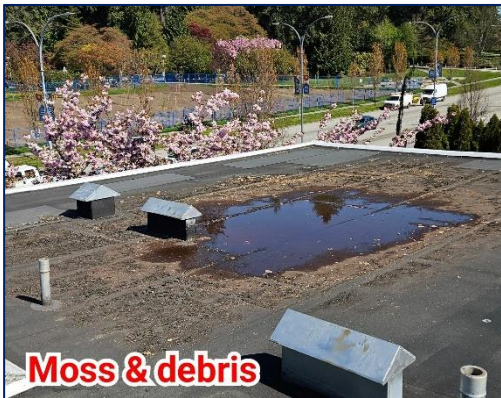
Before: Debris and loose moss at roof surfaces.

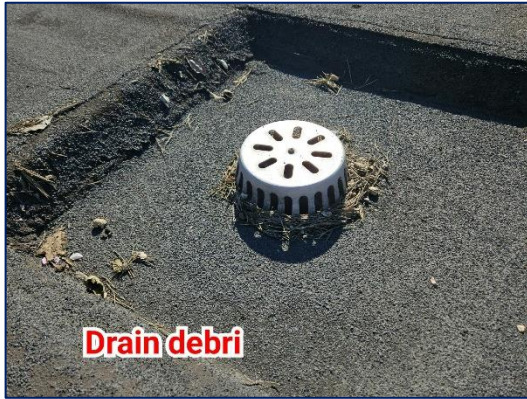
Before: Debris and loose moss in drains at roof level.

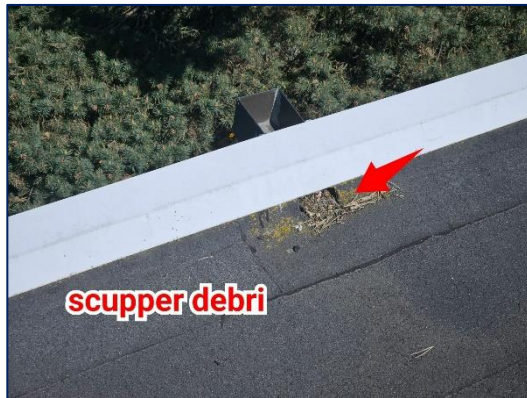
Before: Debris and loose moss in scupper drain at roof level.

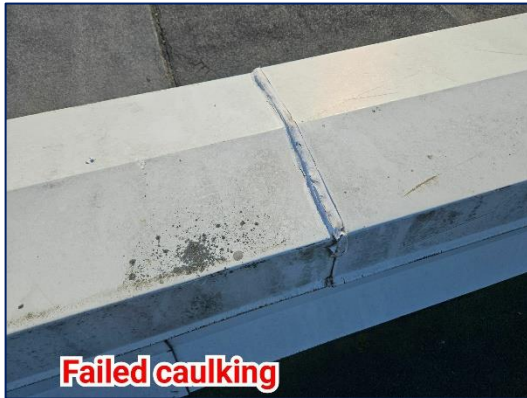
Before: Deteriorated caulking at metal flashing seams.

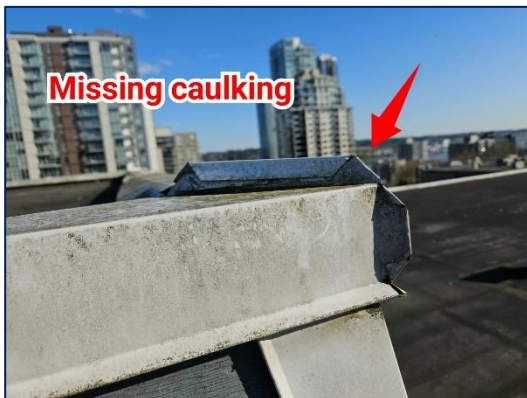
Before: Deteriorated caulking at metal flashing seams.

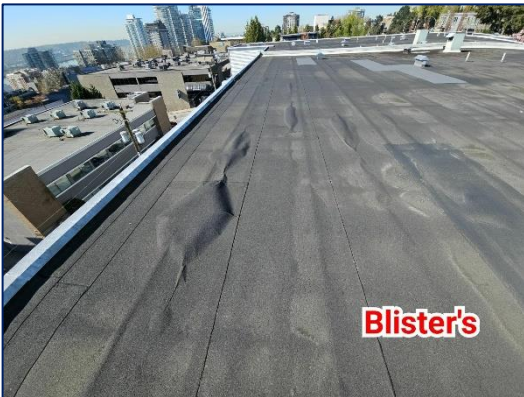
Before: Inspected roof surfaces for most critical blister locations.

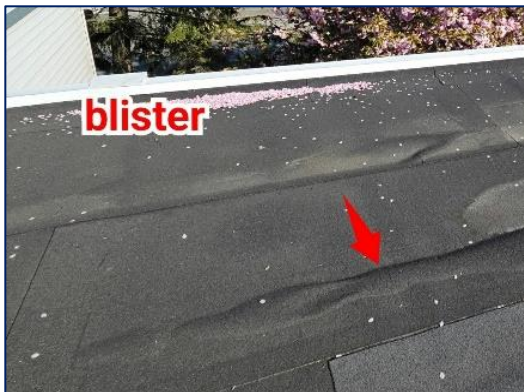
Before: Inspected roof surfaces for most critical blister locations.

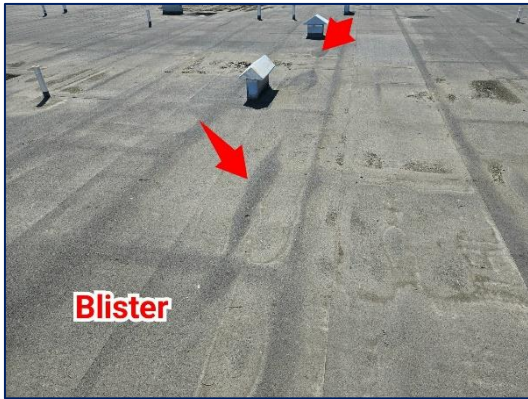
Before: Inspected roof surfaces for most critical blister locations.
