RAINSHIELD ENGINEERS INC.
PROJECT NO: R23-032

2024 Depreciation Report

At 550 Royal Avenue, New Westminister, BC

Strata Corporation Plan NW 1592- Harbourview

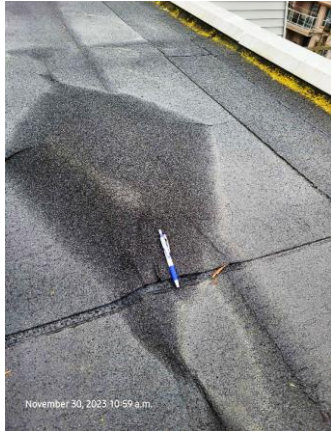
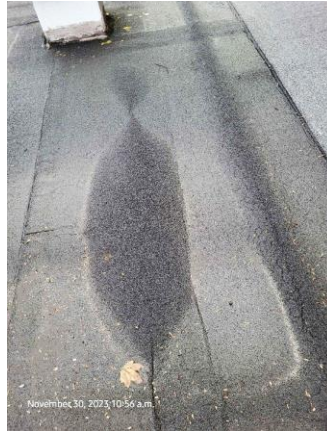
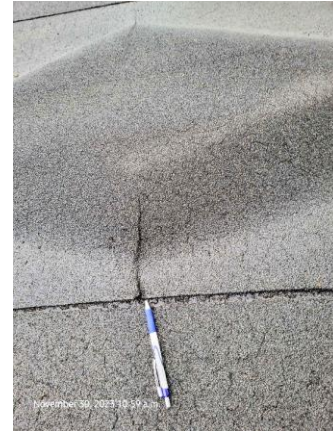
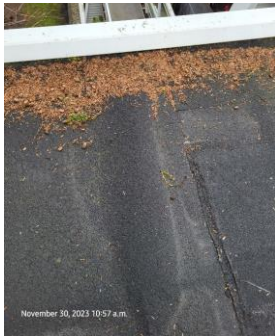
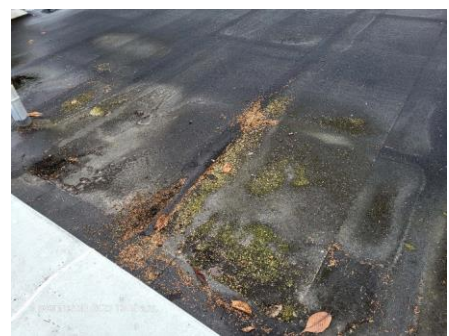
The waterproofing membrane had aged and reached beyond the service life. Replacement is required.

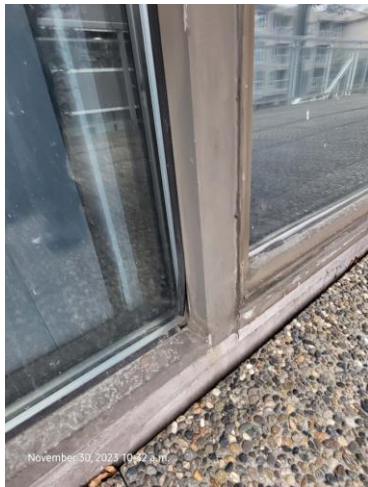
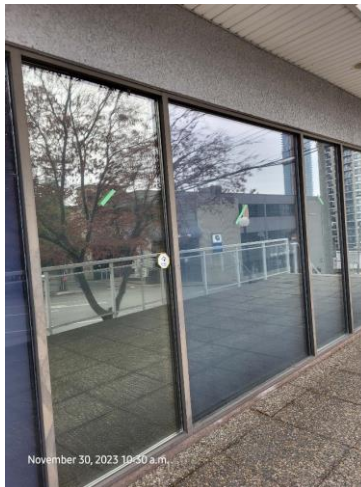
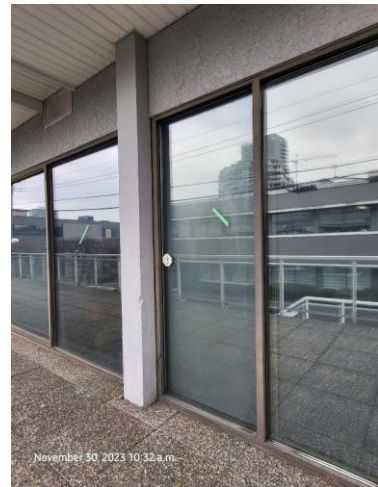
It was reported that approximately 30% of the existing insulated glass units have failed and condensation has occurred in the insulated glass units.

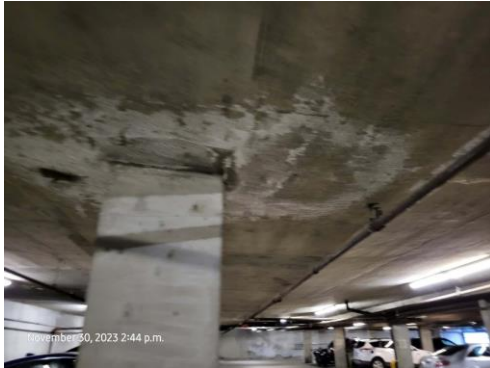
There were many locations of the past localized repairs with epoxy injection and crystalline concrete. Note that the past repairs are temporary, and the primary waterproofing membrane will eventually have to be replaced. Keep monitoring.

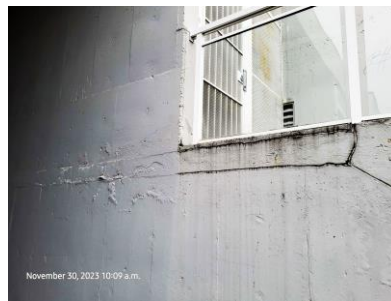
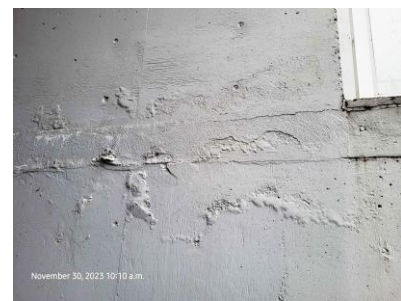
Considerable water ingress was noted on the walkway beside the loading area.

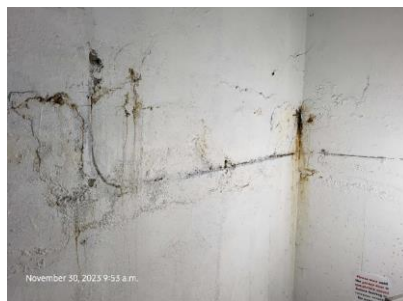
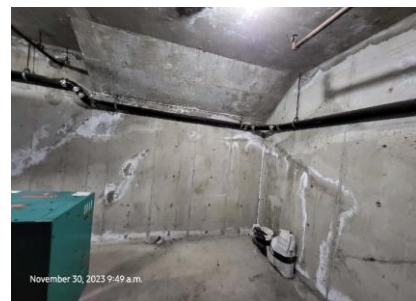
At the time of the visit, concrete cracks and water stains were observed at many foundation wall areas.

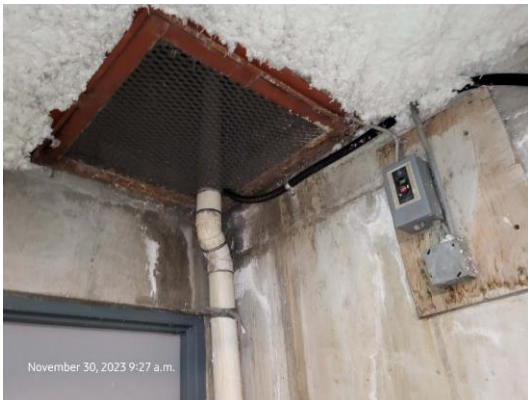
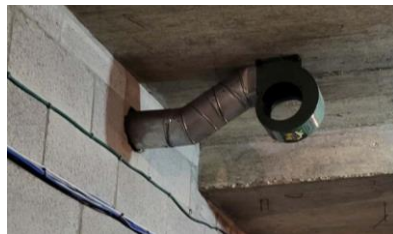
The fans in P1 electrical room and maintenance room were missing.
